Manhole Inspection Summary

Manhole # S13KK1079MH

Record Plat: **13KK1** Node: **079** Status: **New Manhole (Not in GIS)** Insp Date: **12/14/06 1:14 PM**

Location Address: **2859 EDGECOMBE CIR**

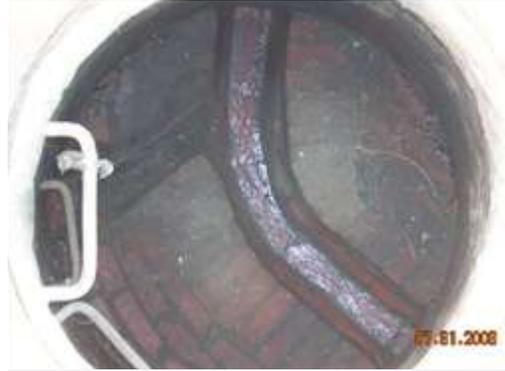
Top View

Evidence of surcharge - Bench debris.
Channel debris.

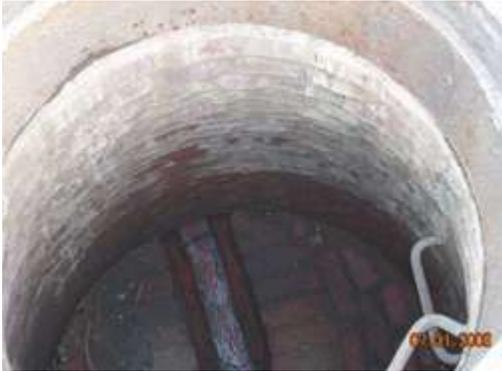
Defect

Frame leaks. Corbel deterioration and infiltration. Barrel infiltration - other side.

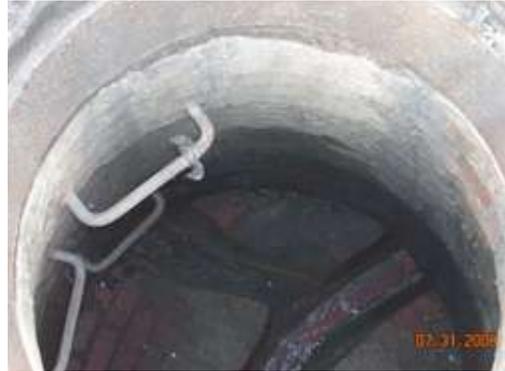
Defect

Frame leaks. Corbel deterioration and infiltration. Barrel infiltration.

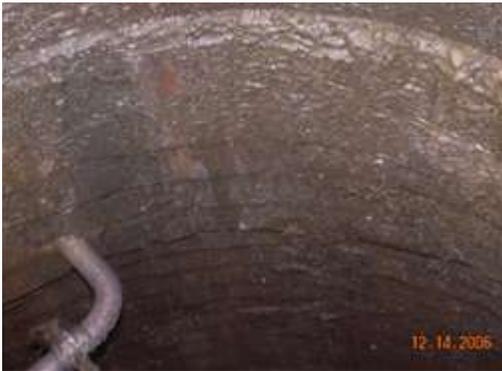
Defect

Frame leaks. Corbel infiltration.

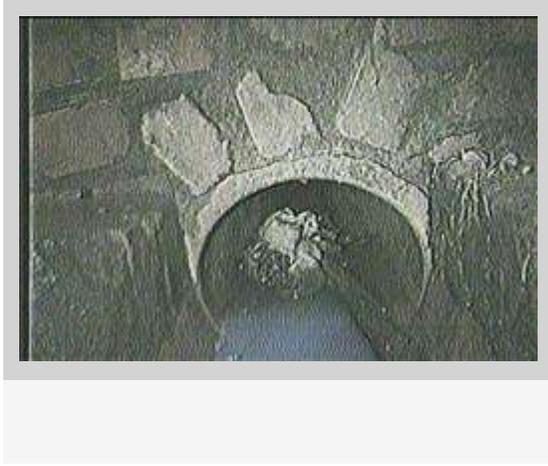
8 in. Circular Gravity Sewer
Pipe Out @ 12 O'Clock

Invert Depth: **6.91** (ft.) Flow Characteristics: **Slow**

Deposits: None Mud Sludge **Debris** Grease

Silt Depth: **0** (in.) Deposits Extent: **Light**

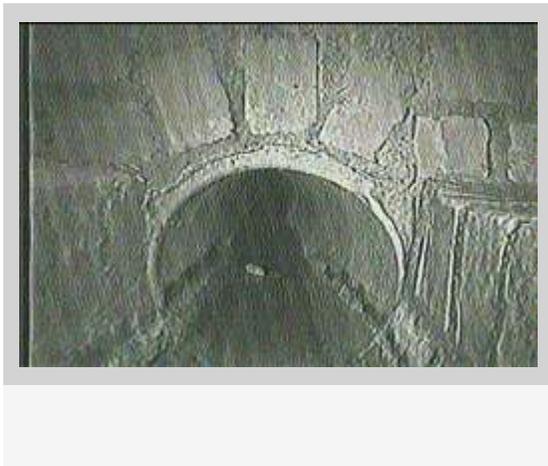
8 in. Circular Gravity Sewer
Pipe In @ 4 O'Clock

Invert Depth: **6.70** (ft.) Flow Characteristics: **Slow**

Deposits: None Mud Sludge Debris **Grease**

Silt Depth: **0** (in.) Deposits Extent: **Light**
